National Implementations

Johnston County Pilot Project

- Safety Edge versus No Safety Edge

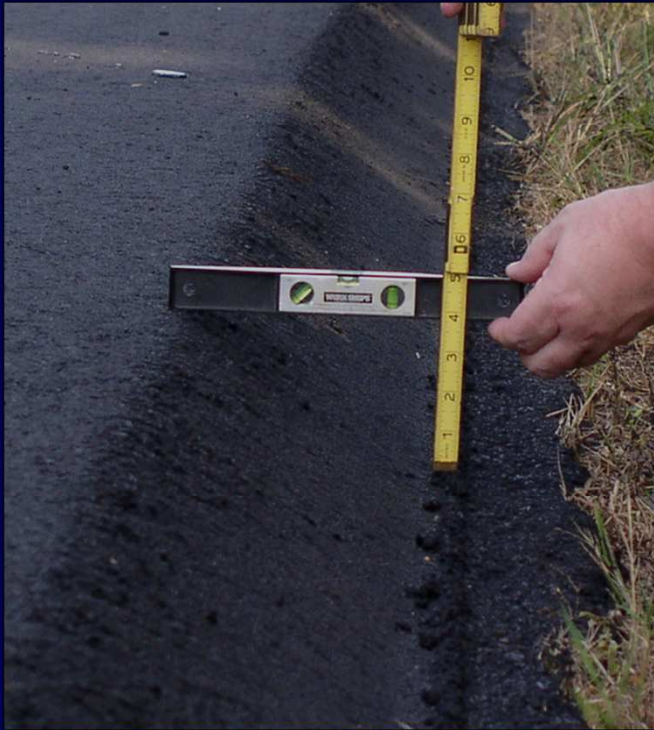
With Safety Edge

This slide demonstrates the 30 degree shaped and formed pavement edge created by using a safety edge device VERSUS the standard pavement edge that is approximately 45-60 degrees with a non-shaped and non-formed pavement edge that crumbles and breaks off leaving a potential 90 degree pavement edge. Photos above are from a Georgia Safety Edge Implementation.

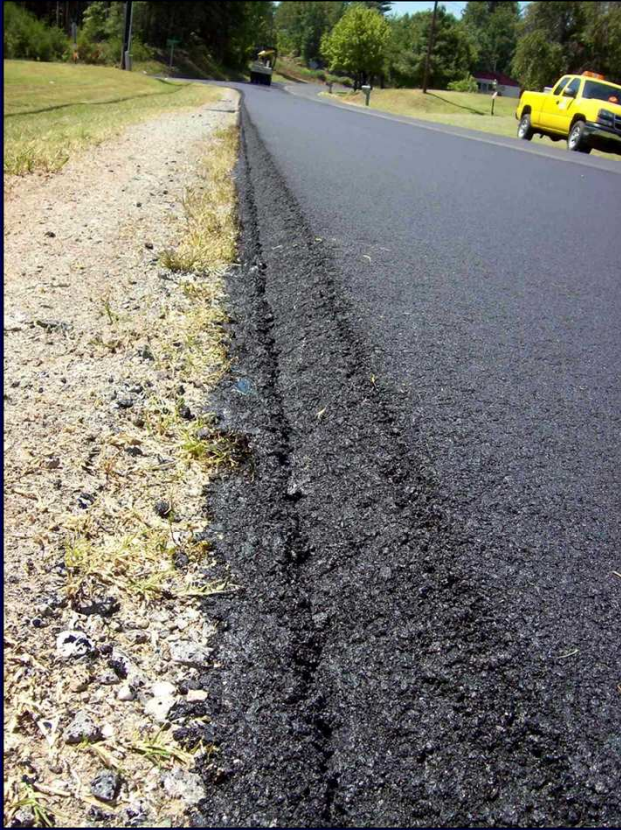
With Safety Edge

The photos above were taken during implementation on Part B of the resurfacing project. The left side is WITH Safety Edge (southern shoulder), the right side is WITH OUT Safety Edge (northern shoulder). Notice the 30 degree shaped and formed pavement edge (safety edge) in the photo on the left. Notice the 60-90 degree with a non-shaped and non-formed pavement edge (standard edge) that crumbles and breaks off in the photo on the right.

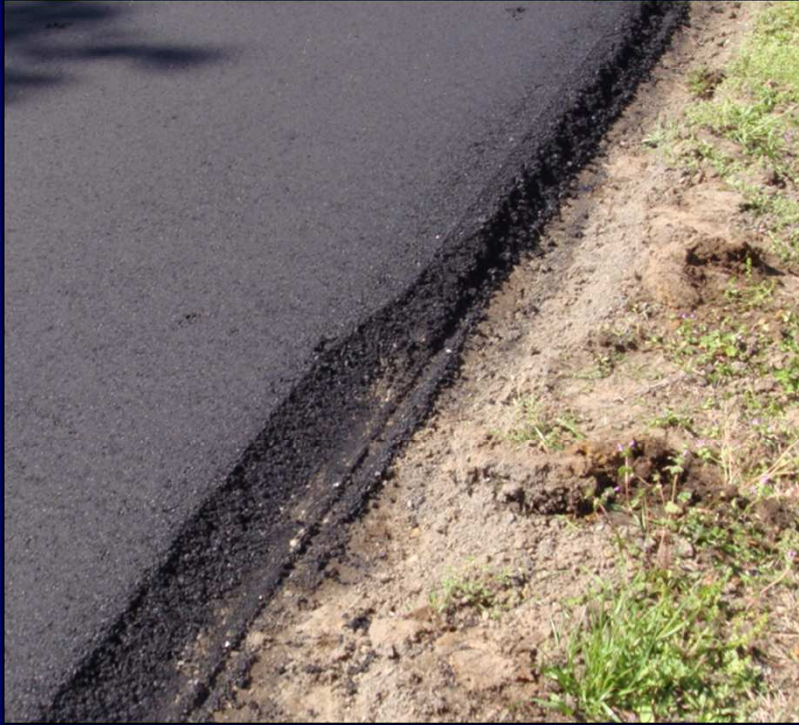
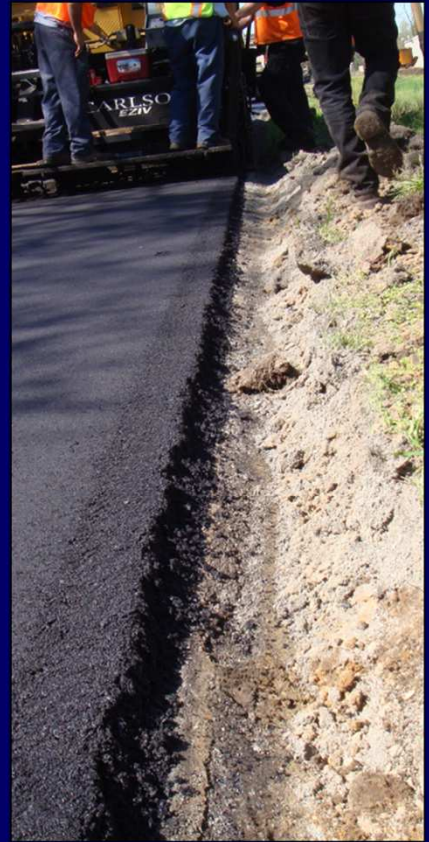
FHWA visited a few of the Pilot Project sites and needed to take sample densities with and without the safety edge device in play. The photos above demonstrate the edge of pavement with and without safety edge. The safety edge was raised for approximately 1000 feet for the density test sections. We have not yet received the results of this testing. The next two slides represent the same.

Photos from April 6, 2011. Map 4 – SR 1007 (2.10 miles). 1.5" Lift, Warm Mix. Shoe – NCDOT Prototype 2.

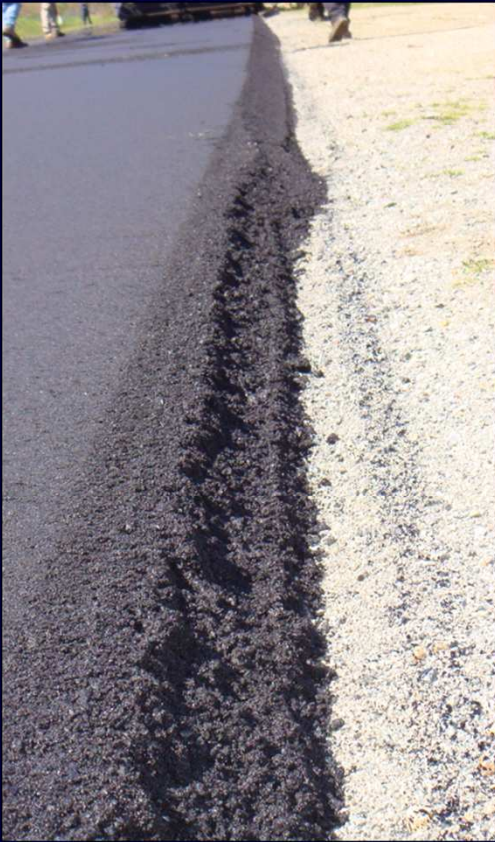
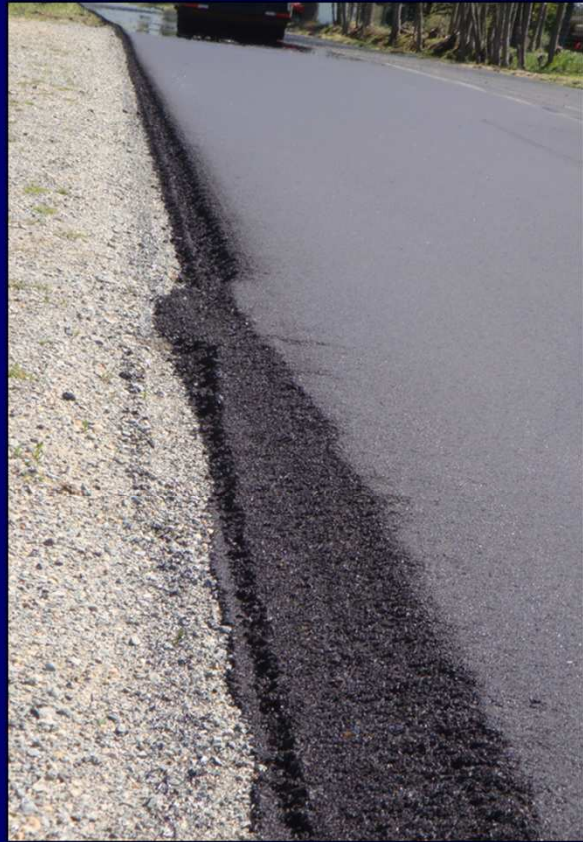
FHWA visited a few of the Pilot Project sites and needed to take sample densities with and without the safety edge device in play. The photos above demonstrate the edge of pavement with and without safety edge. The safety edge was raised for approximately 1000 feet for the density test sections. We have not yet received the results of this testing.

Photos from April 6, 2011. Map 4 – SR 1007 (2.10 miles). 1.5" Lift, Warm Mix. Shoe – NCDOT Prototype 2.

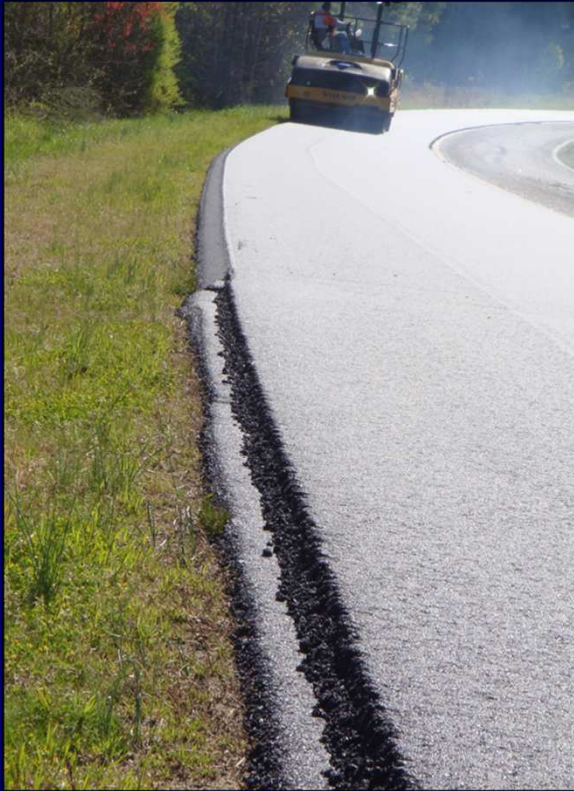
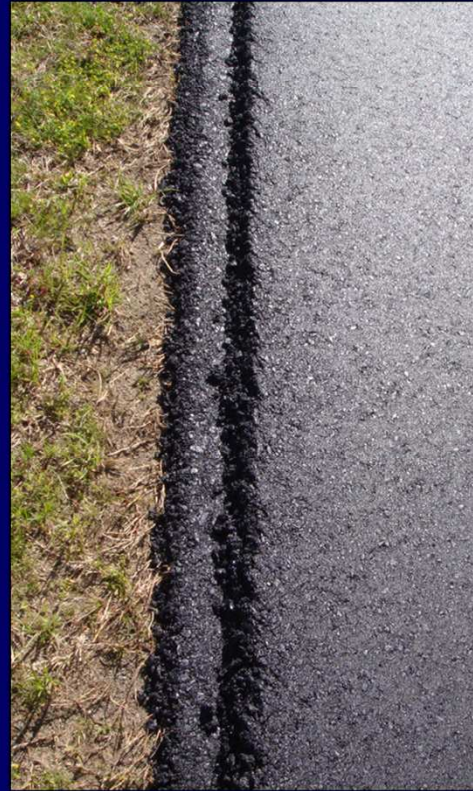
FHWA visited a few of the Pilot Project sites and needed to take sample densities with and without the safety edge device in play. The photos above demonstrate the edge of pavement with and without safety edge. The safety edge was raised for approximately 1000 feet for the density test sections. We have not yet received the results of this testing.

Photos from April 7, 2011. Map 1 – SR 1938 (1.89 miles). 1.5" Lift, Hot Mix. Shoe – Carlson End Gate.
